## SUMMARY REPORT

**Inspection of :** Saffold Fire Escape Ladder.

**SGS Reference :** CST155864/1/S/FH/12.

**Specification :** Load tests with reference to:  
BS EN ISO 131-2:2010.  
Ladders.  
Part 2: Requirements, testing, marking.

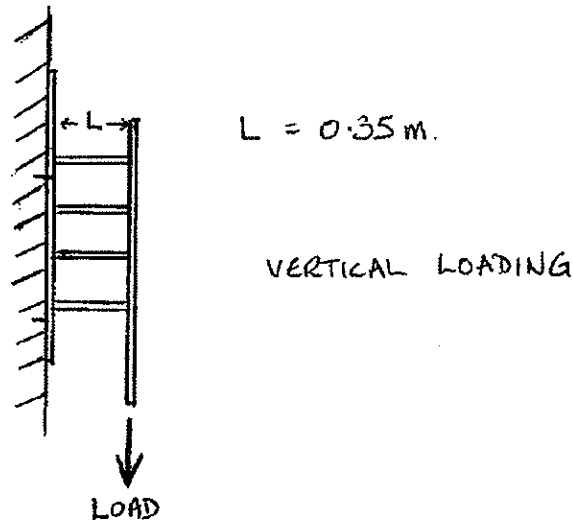
### Vertical load test.

The ladder was loaded at the outside limit of the rungs; thus exerting maximum force on the rungs and fixings.

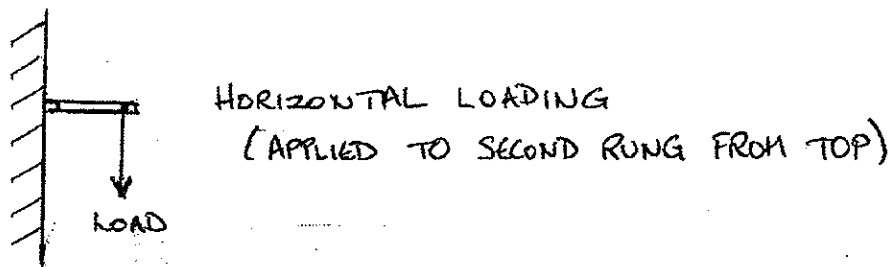
### Horizontal load test.

The ladder was again loaded at the outside limit of the rungs; thus exerting maximum force on the rungs and fixings.

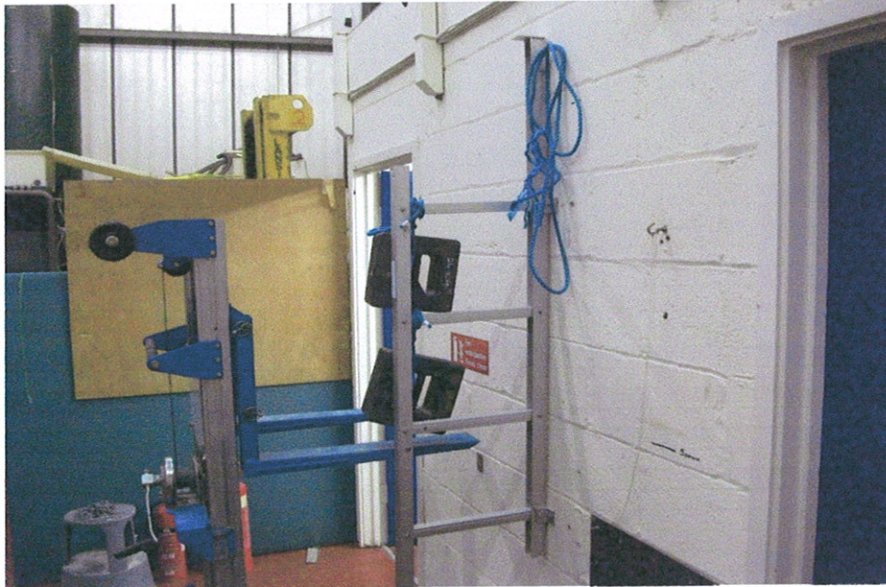
**Initial vertical set-up with 50kg load.**

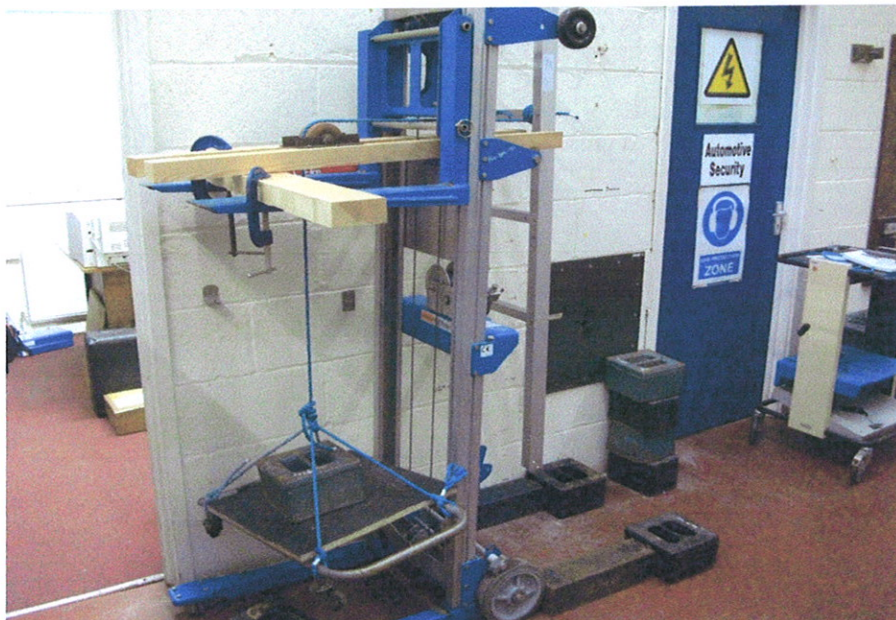
**Initial horizontal set-up with 25kg load.**

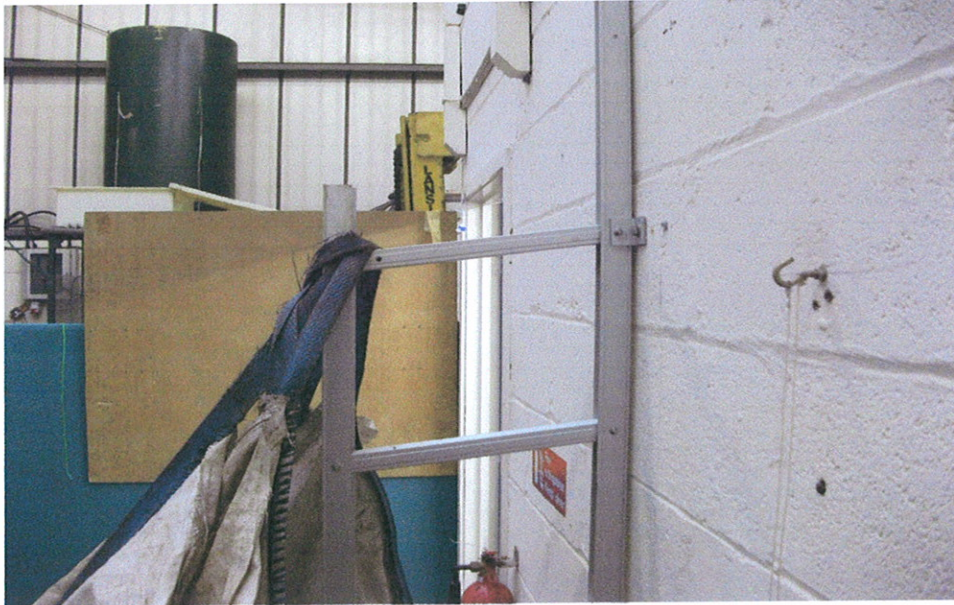
The ladder was subjected to a vertical load of 345kgs for ten minutes.

The rungs inclined downward at the outer end by 7.5 degrees to the horizontal during the test. The stiles started to deform on the outside surface due to the pressure exerted by the ends of the rungs. This deformity was permanent.

**Final vertical test with 345kg. Rung angle 7.5degrees**

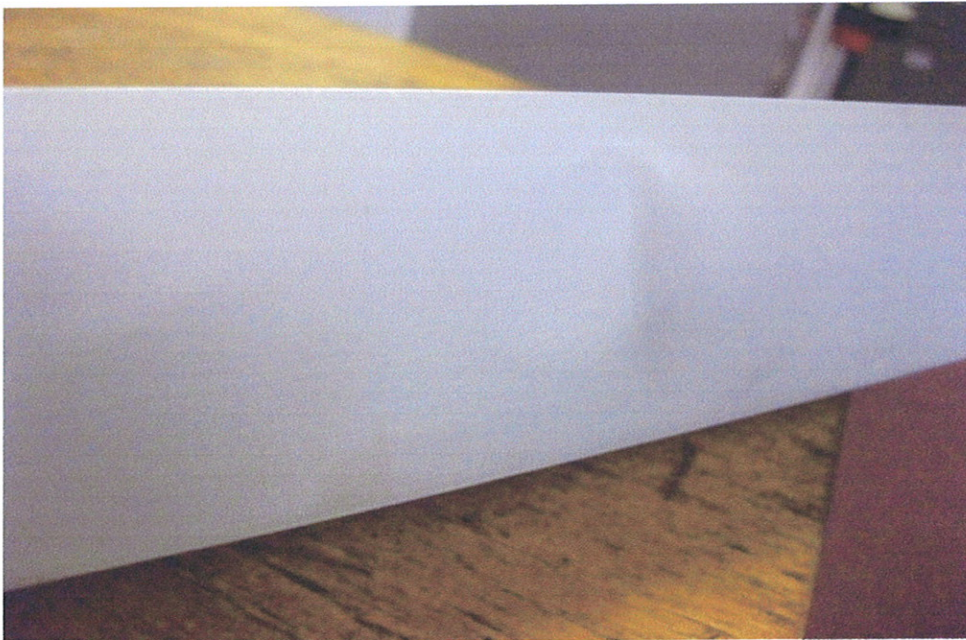
**Deformity caused by end of rung on stile.**
