C A M B R I D G E  
**FIRE RESEARCH**

**REPORT NUMBER**  
**CFR1712201\_2**

**FIRE RESISTANCE TEST**  
**IN ACCORDANCE WITH BS 476: PART 22: 1987**

A timber single acting latched doorset tested as an insulated doorset with self-adhesive stick-on seals to jambs and head of frame.

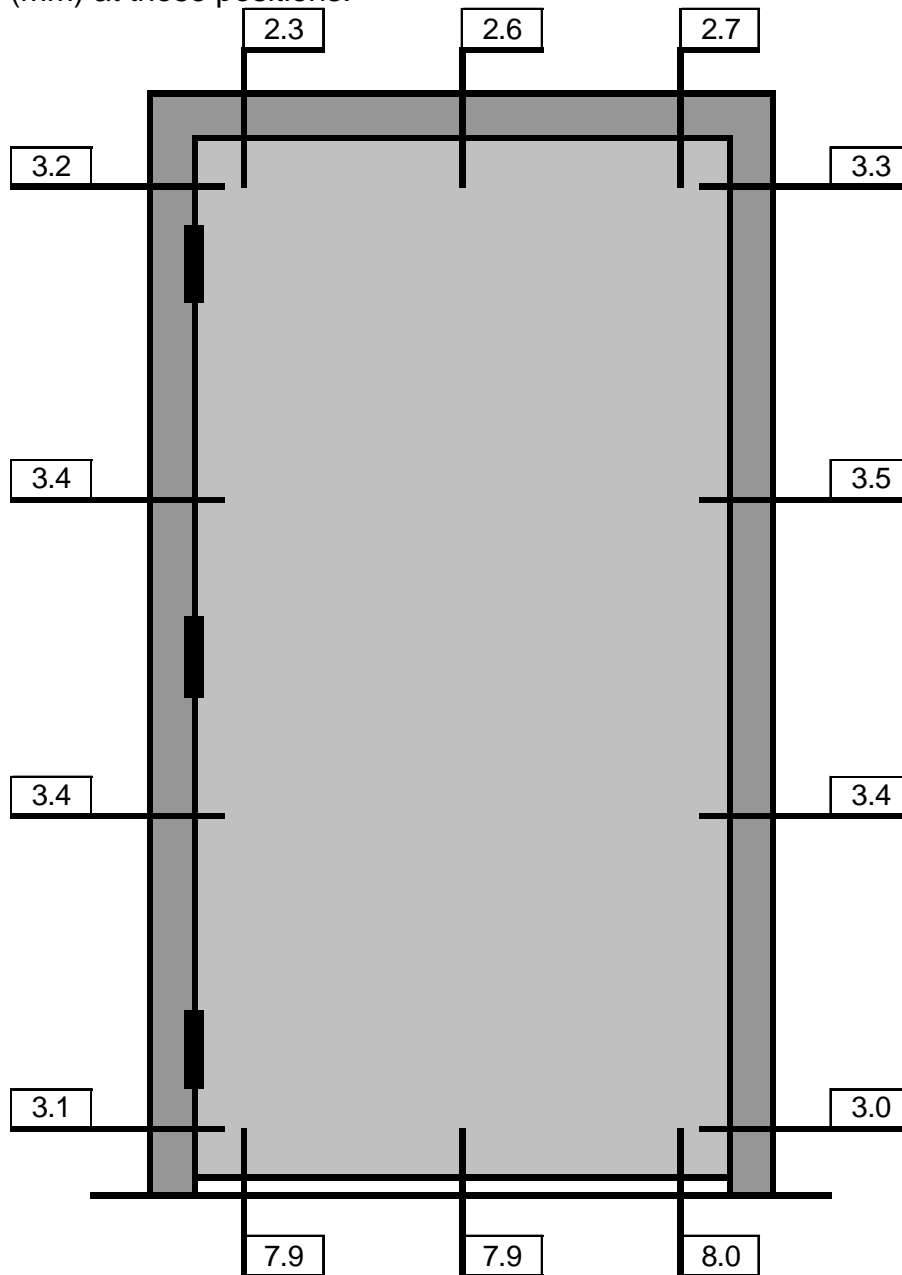
The gap between the leaf edges and the frame and at the threshold was measured on the exposed face prior to the start of the test and prior to the fitting of the frame intumescent. The following figure shows the position at which the measurements were made and the recorded gap (mm) at those positions.

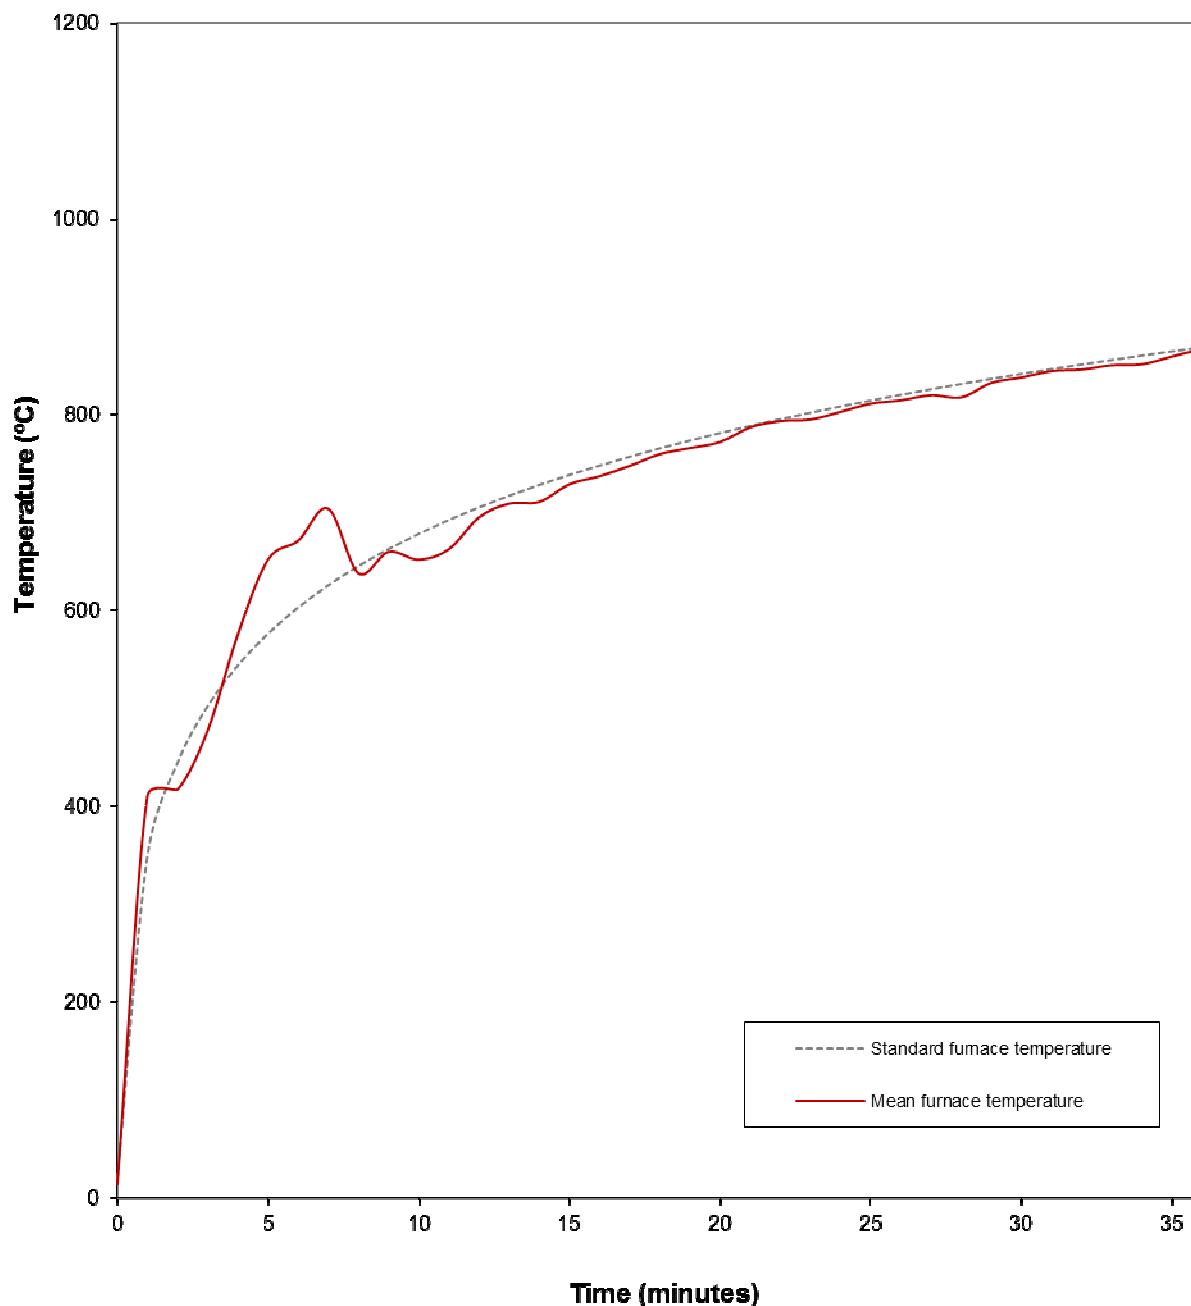
Furnace temperature was controlled so as to follow the standard temperature/time curve defined in the test standard and within the tolerances permitted. The furnace mean temperature was calculated from the output recorded using five furnace thermocouples of the design specified in the test standard. The following graph shows the standard and mean furnace temperature/time data.

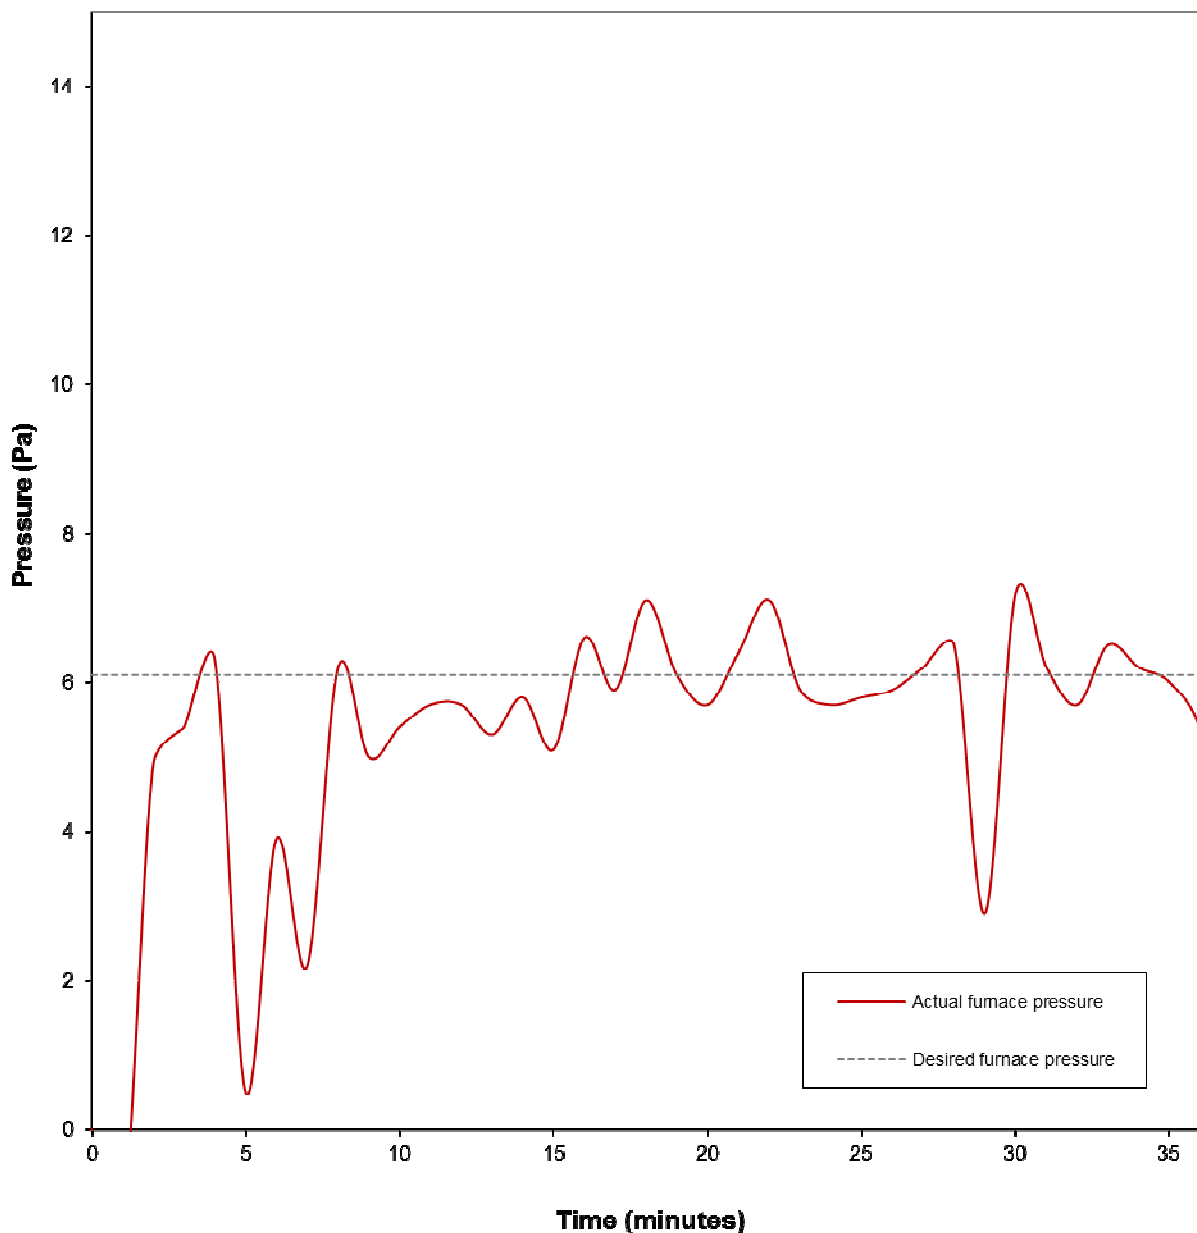
Furnace pressure was maintained for the duration of the test at a nominal + 6.1 Pa measured at the pressure sensing head. When a linear pressure gradient of 8.5 Pa/m is applied this equates to + 0 Pa at 1 m above the notional floor level. The furnace pressure was controlled within the tolerances permitted in the test standard except for 4 instantaneous occasions which were transient events. The following graph shows the actual and desired furnace pressure/time data.

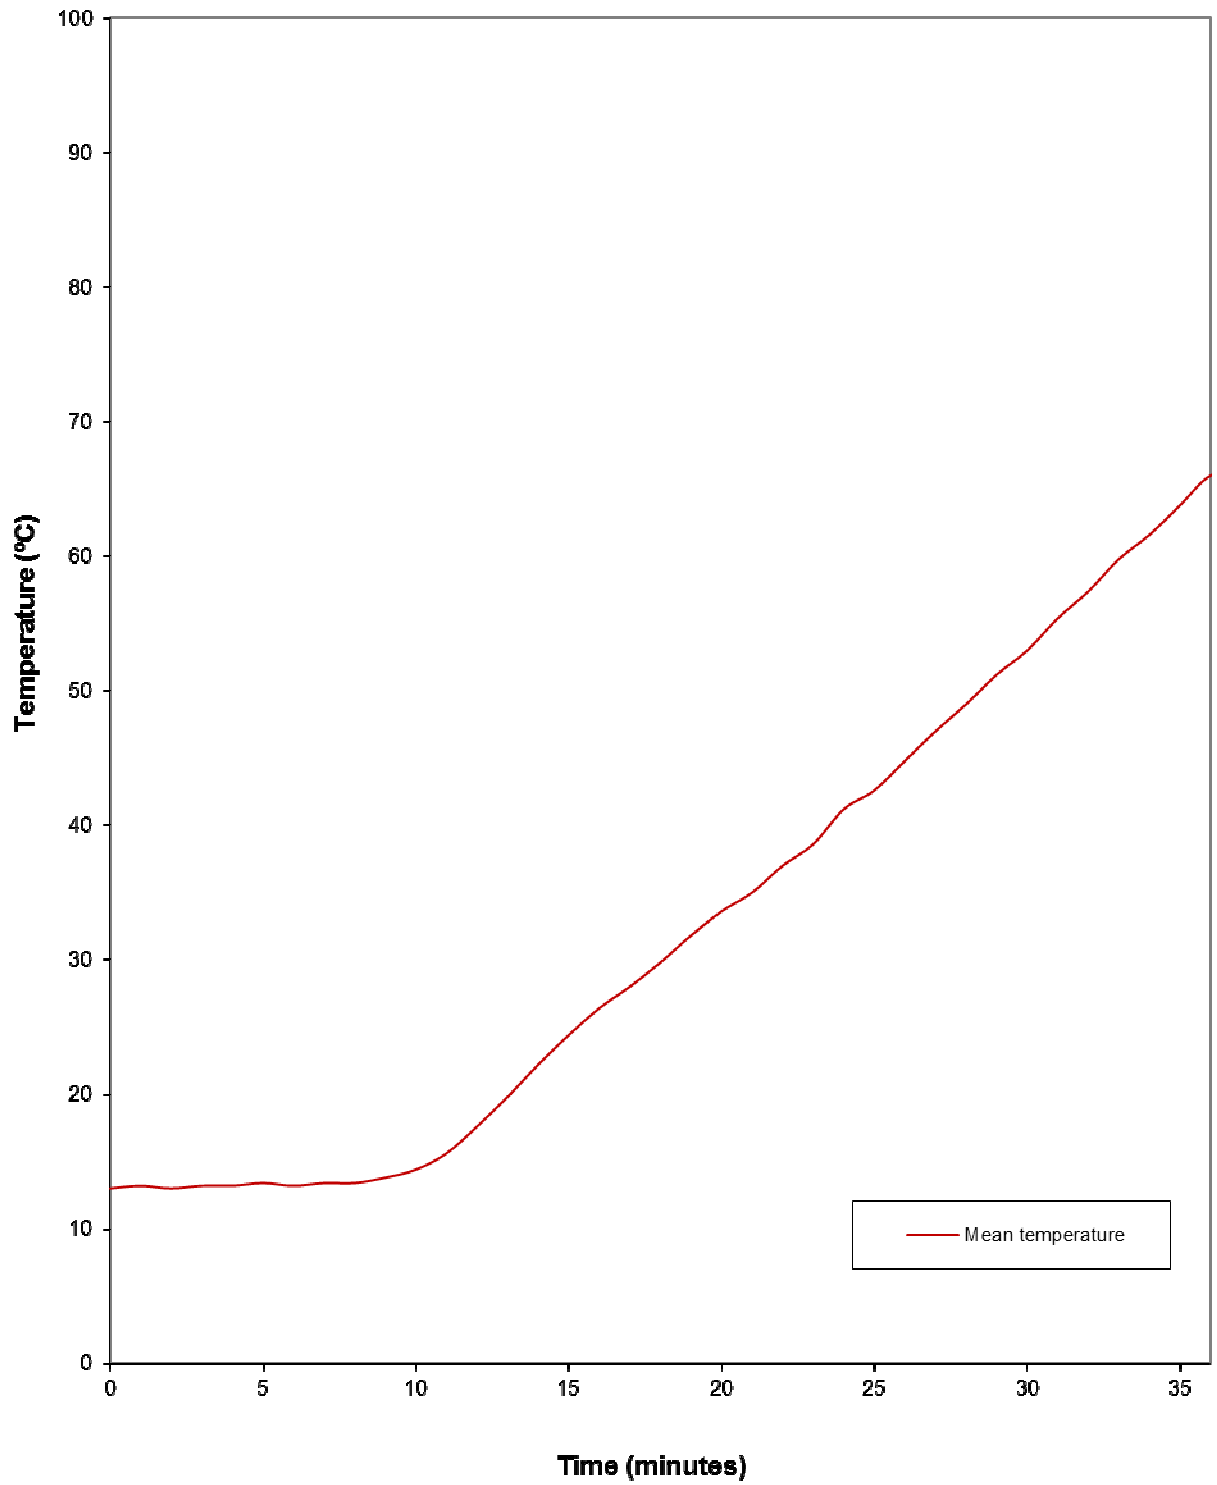
The following time/temperature graph shows the mean leaf temperature.

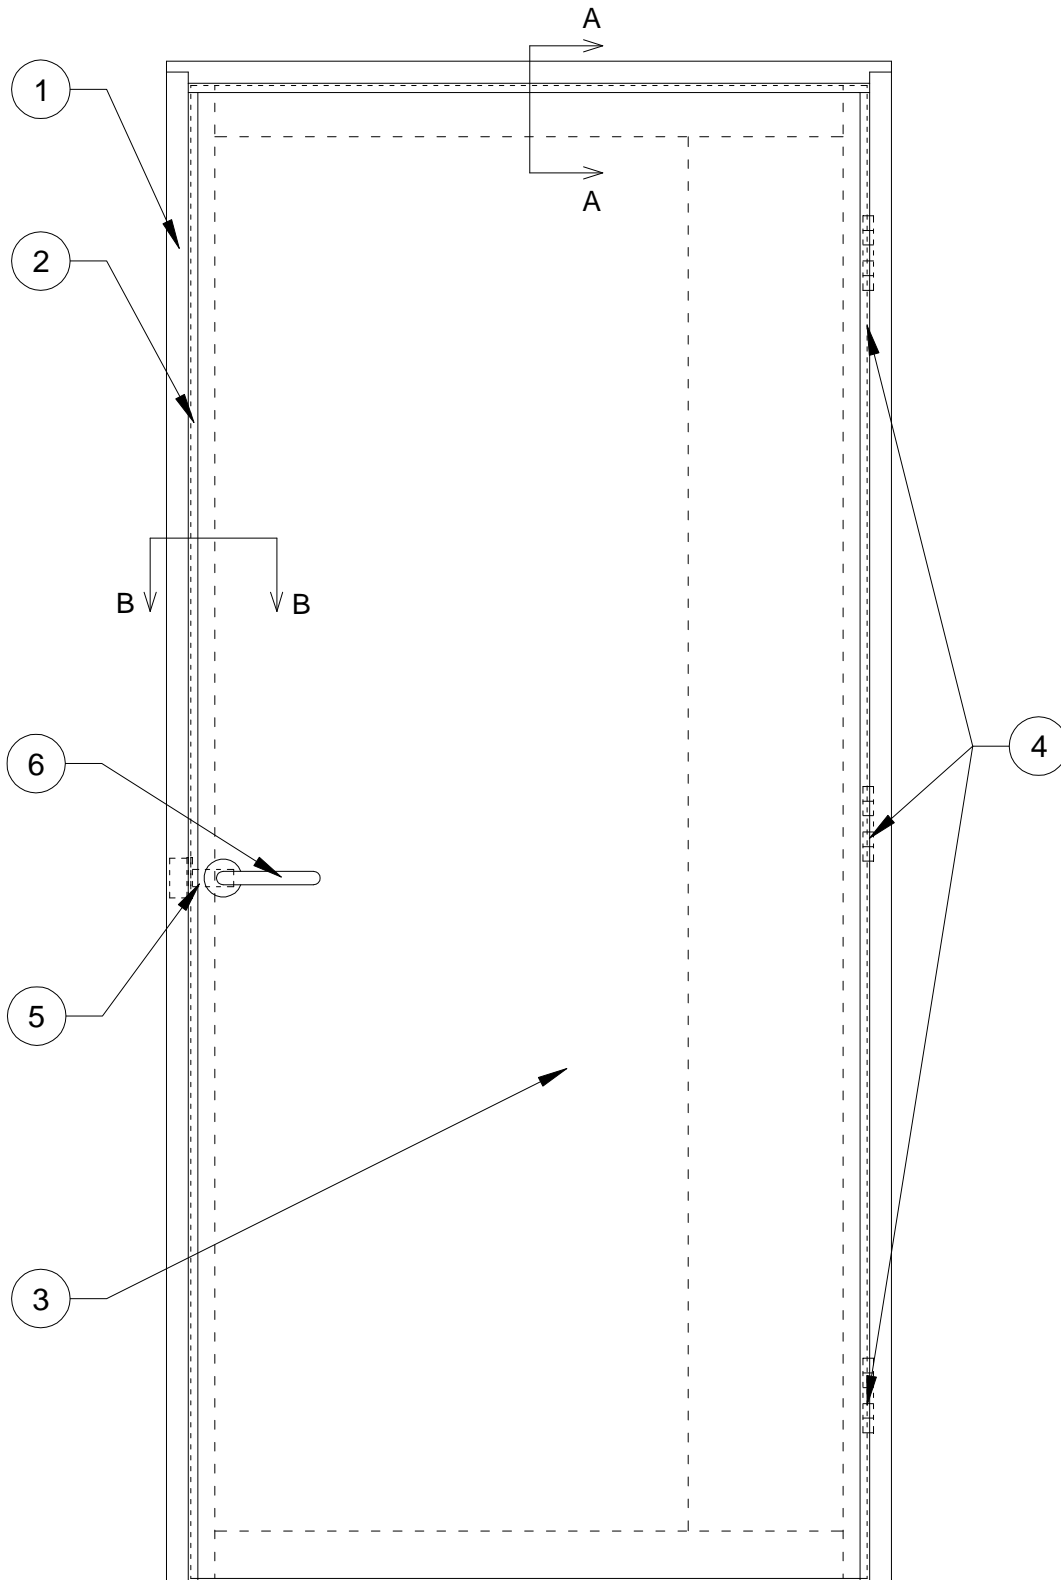
Appendix 1 Figure 1 – Elevation viewed from the unexposed side incl. hidden detail

The item numbers listed in Appendix 1 Table 1 and shown in the figures in Appendix 1 refer to the components of the specimen construction. Any photo numbers refer to those in Appendix 2.

Item	Component	Information
1	<p><b>Frame</b> Supplier: Description:</p> <p>Density (kg/m<sup>3</sup>): Fixing to associated construction:</p> <p>Overall size (h x w x d): Cross section size (h x d):</p>	<p>Cotswold Doors A 3 sided MDF** frame with 15 high rebated joints affixed vertically using 2No Ø3.9 x 60 steel countersunk woodscrews at 45 centres. 710* ** The jambs are affixed to the associated construction using No.10 x 3" steel countersunk wood screws positioned 220 down, 250 up and 3No. equispaced. 2080 x 993 x 100 30 x 100</p>
2	<p><b>Stops</b> Supplier: Description:</p> <p>Density (kg/m<sup>3</sup>): Overall size (h x w x t):</p>	<p>Cotswold Doors MDF** stops with butt joint at corners affixed to frame with steel pins 16swg x 50 long at 290 to 380 centres, with 5 fixings in head and 7 fixings per jamb. 710* ** 13 x 32</p>
3	<p><b>Leaf</b> Supplier: Description:</p> <p>Overall size (h x w x t): Weight (kg):</p> <p><b>Sub-components:</b> Core: Manufacturer: Type: Description: Density (kg/m<sup>3</sup>): Overall size (h x w x t): Rails: Manufacturer:</p>	<p>Cotswold Doors A Vicaima FD30 door with softwood stiles** and rails**, MDF facings** and hardwood lippings to vertical edges. 2040 x 925 x 44 61.2 including hinges and latch.</p> <p>Vicaima Particle board** 2 part core with vertical joint‡ 510** 1905‡ x 862** x 38** Vicaima**</p>

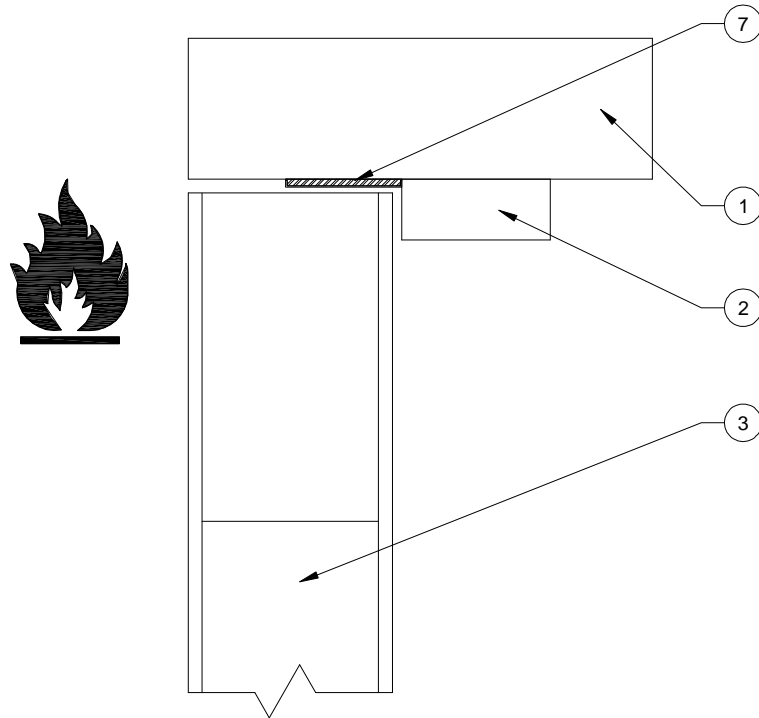
Appendix 1 Figure 2 – Section A – A

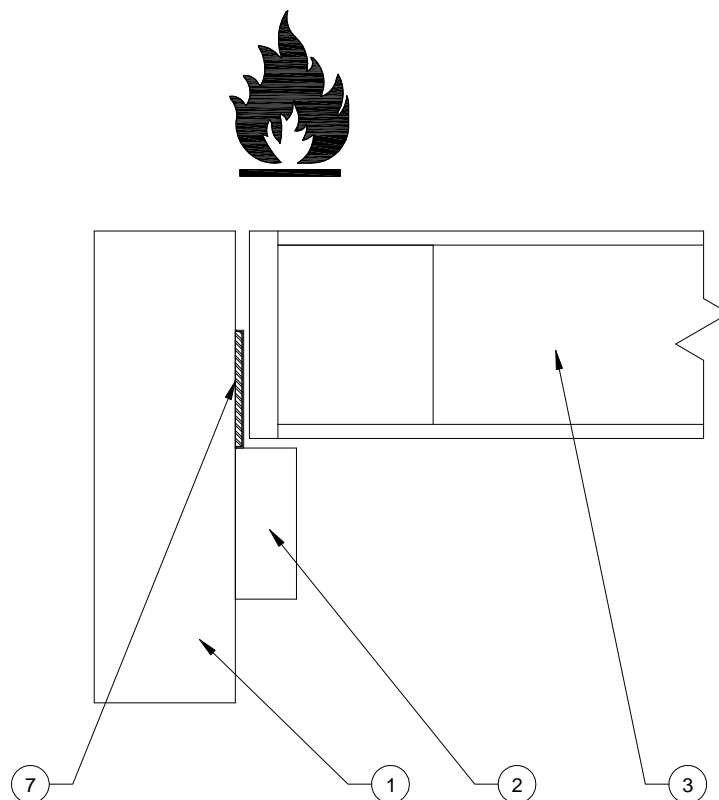
Appendix 1 Figure 3 – Section B – B

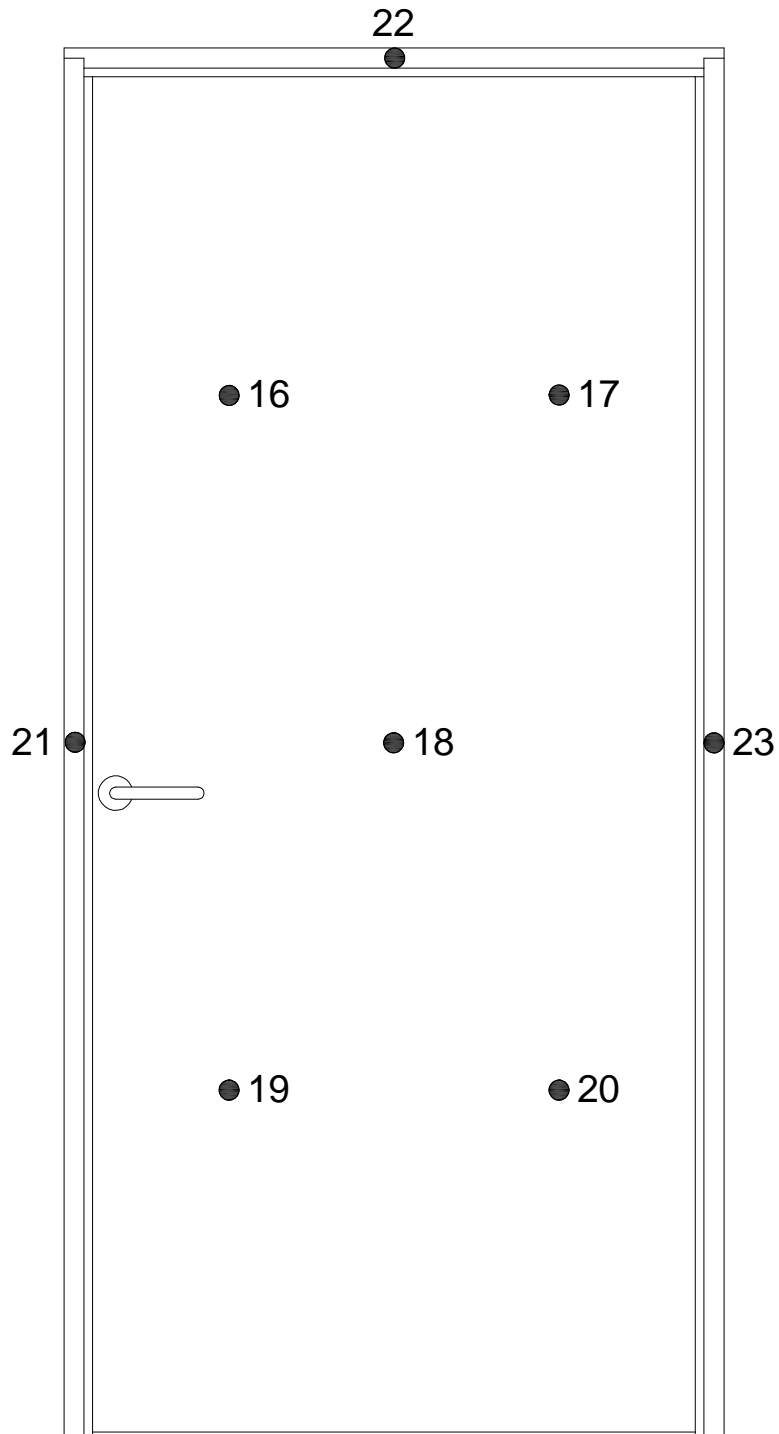
Doorset	Channels 16, 17, 18, 19 and 20	(mean & maximum)
Doorset frame	Channels 21, 22 and 23	(maximum only)

● Unexposed face specimen thermocouple

The positions of these thermocouples are shown in Appendix 3.
